IMPACT DAMAGE INFLUENCE ON VIBRATION CHARACTERISTICS OF WOVEN COMPOSITES

Abstract. The present paper investigates the influence of impact damage on vibration characteristics of woven composites. For this purpose, small plate specimens with dimensions of $60 \times 70 \times 1.5$ mm were cut from the large panel made of carbon fiber woven composite with five-layers. The damage was introduced into the tested specimens in the energy range of 2-6 J by INSTRON Dynatup 9250 HV Impact Tower and accurately characterized by application of pulse-echo ultrasonic scanning technique: Hillger ultrasonic system USPC 3010 HF. Finally, the dynamic characteristics: natural frequencies and corresponding loss factors are determined from the free vibration analysis of impacted specimens by using POLYTEC PSV-500 laser vibrometer operating on the Doppler principle. The results show that damage shifts the natural frequencies of plates and increases their damping properties. Therefore, changes in dynamic characteristics, especially in loss factors, can be used for structural health monitoring. It was found that damaged areas higher than 6% of the specimen's total area affect significantly loss factors of

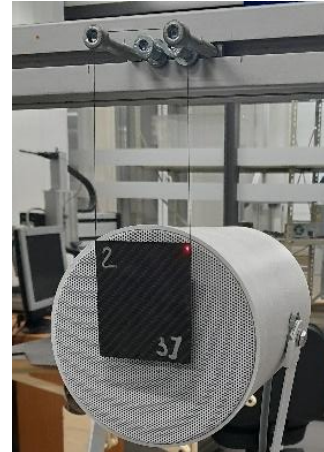
Fig. 3. Specimen with free-free boundary conditions excited by loudspeaker

All specimens were measured by POLYTEC PSV-500-3D Scanning Vibrometer (Fig. 3) before and after the impact in frequency range of 0-6.4 kHz with step of 0.5 Hz to determine their natural frequencies and corresponding loss factors. The frequency range was chosen to obtain 8 natural frequencies. The smallest possible step for this frequency range was applied to determine the loss factors by the peak-picking method [4] with the possible higher accuracy. Taking into account small weight of the specimens, non-contact excitation by the loudspeaker was applied to eliminate the influence of the weight of the excitation device [14]. Free-free boundary conditions were physically realized by hanging the specimen on a thin thread that minimizes the influence of fixation on the dynamic properties of the specimen.

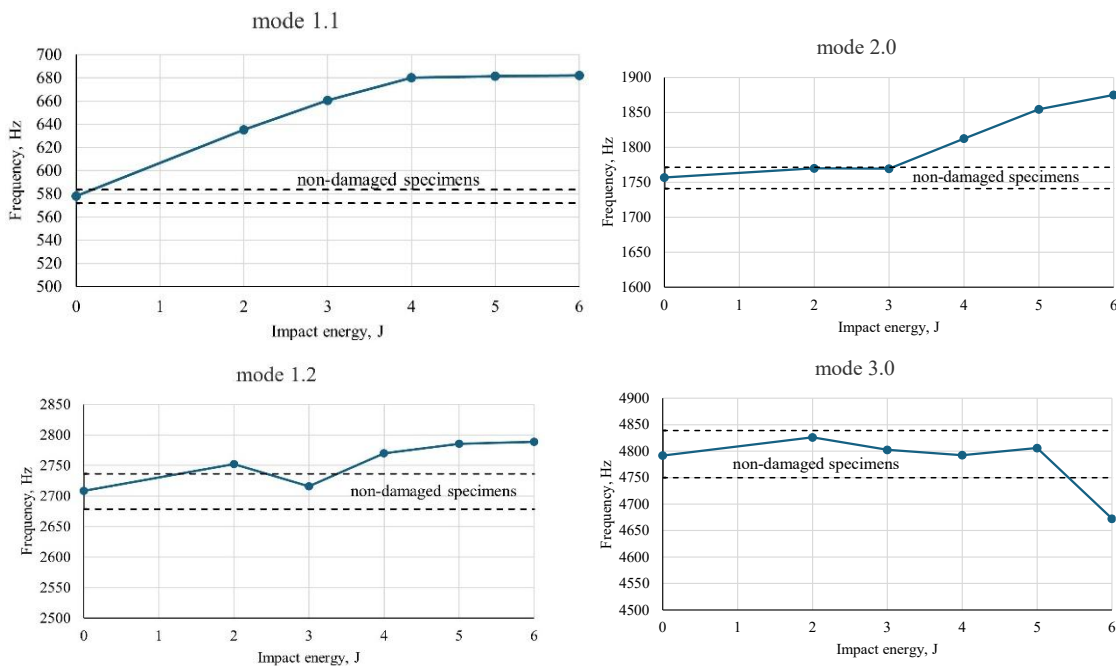
Fig. 5. Dependencies of specimen natural frequencies on impact energy

Eight resonances were found for each specimen by analysing their frequency responses obtained by the laser vibrometer. Since the vibration tests were executed for all specimens before impact, the boundaries of each natural frequency and corresponding loss factor of non-damaged specimens were determined. Changes in dynamic characteristics caused by the impact were analysed relative to this range. The results show the increase of natural frequencies on the applied impact energy (Fig. 5). This effect could be explained by the residual curvature introduced by the impact (Fig. 6), that increases the geometrical stiffness of the initially plane plate specimen. Increase of stiffness caused by this curvature is higher than the reduction in stiffness caused by material destruction in the impact zone. It is necessary to note that this effect is more visible for lowest vibration modes - both twisting (mode 1.1 in Fig. 6) and bending (mode 2.0 in Fig. 6). For higher vibration modes (twisting mode 1.2 and bending mode 3.0 in Fig. 5) the influence of the impact energy on natural frequencies is smaller. For mode 3.0 also the decrease of natural frequency is observed in case of the highest impact energy (6 J).
