TRIBOLOGICAL ANALYSES OF COMPOSITE MULTILAYER COATINGS APPLIED FOR MOLDS IN TIRE PRODUCTION

Abstract. The goal of this work is to determine the suitability of cobalt-based powder used in coating aluminum forms, using atmospheric plasma spraying. The experimental part is focused on evaluation of the performed analyses and practical tests to determine the suitability of the coating in practice. The goal of the experimental part of this work was to evaluate the applicability of coating aluminum molds used for vulcanization of tires. Cobalt-based powder was used for coating. Firstly, by itself, secondly, together with a NiAl intermediate layer. Both layers were applied using the method of atmospheric plasma spraying. The desired result of these coats was to increase their lifespan, increased amount of work cycles between necessary cleaning of the mold and simplification of maintenance. The NiAl intermediate layer used along cobalt - based powder in coating resulted in more equally distributed elements in deposited layers, especially cobalt and molybdenum, and near complete reduction in chrome agglomeration. Furthermore, layer adherence was improved due to the creation of heat bridge i

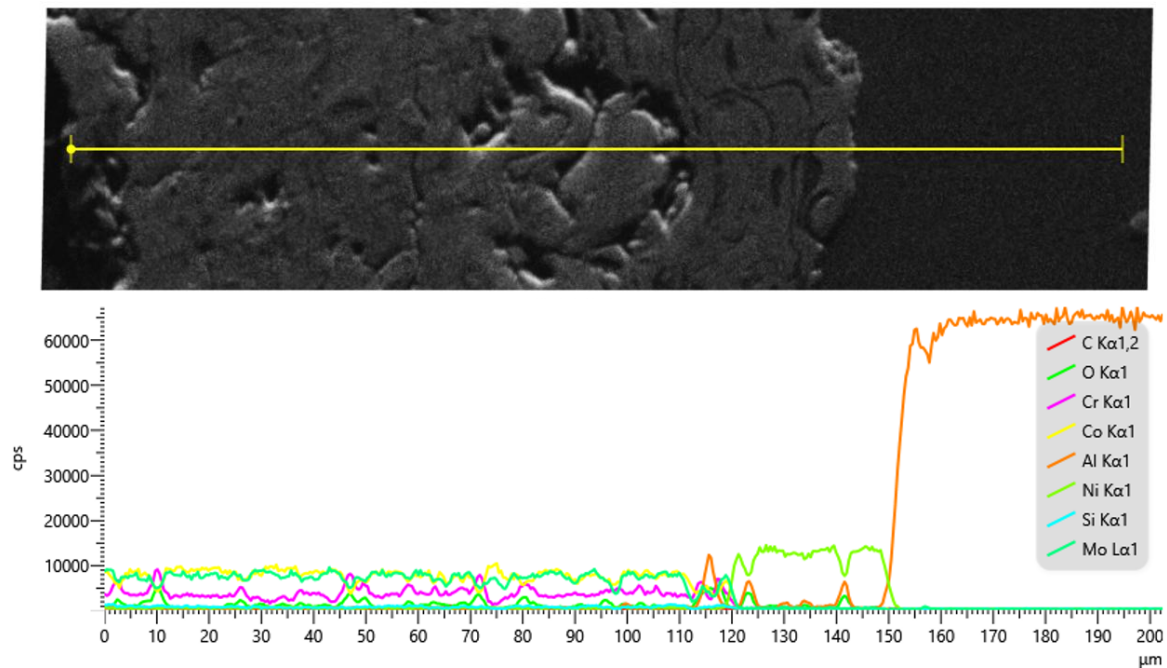
Linear analysis of $\text{Co}_{47}\text{Mo}_{33}\text{Cr}_{18}\text{Si}_2 + \text{NiAl}$ (Fig. 2) provides information on the distribution of elements depending on the depth of the coating. It is evident that the NiAl interlayer becomes approximately 30 μm thick, and the total thickness of the coating increases. The only exception to the relatively homogeneous representation of elements in the section is chromium, which still agglomerates from an otherwise evenly balanced composition. However, this phenomenon is manifested to a much lesser extent than in the coating itself.

Fig. 2. Linear EDS analysis of Co47Mo33Cr18Si2 + NiAl surface

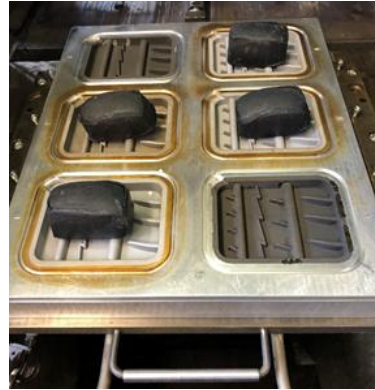
Fig. 3. Mold stored in the machine ready to be pressed with material

Practical, applied tests monitored the behaviour of coated prototypes under repeated loading by rubber vulcanization. The mold sample corresponds to the final sample for tire production, but the shape of the prototypes was adapted to the test conditions. The test prototypes contain buffers that serve to define the test area and are not found on real molds. Defects arising in this area are not indicative of the expected behaviour of the coating during real use in production. The first group of prototypes was coated with Co47Mo33Cr18Si2 powder, the second group contains a Co47Mo33Cr18Si2 coating together with a NiAl intermediate layer. Both coatings were applied to prototypes with summer and winter tread

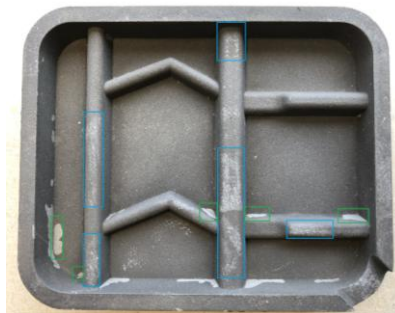
- Peeling of the $\text{Co}_47\text{Mo}_33\text{Cr}_18\text{Si}_2$ coating. These areas are marked in green in Fig. 4. These defects occurred already during the first vulcanization.
- Surface wear, visible in the marked areas of the mold ribs.

Fig. 4. Prototype with $\text{Co}_47\text{Mo}_33\text{Cr}_18\text{Si}_2$ coating with summer tread pattern after rubber vulcanization test

The rubber vulcanization was carried out on molds coated with $\text{Co}_47\text{Mo}_33\text{Cr}_18\text{Si}_2$ METCO powder simultaneously with $\text{Co}_47\text{Mo}_33\text{Cr}_18\text{Si}_2 + \text{NiAl}$ molds. All test conditions were the same for both coatings. In the prototypes coated with pure $\text{Co}_47\text{Mo}_33\text{Cr}_18\text{Si}_2$ powder, two significant defects occurred in particular.

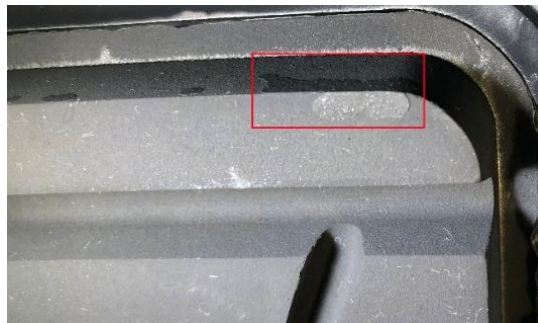
On the first rubber vulcanized in the prototype with deposited $\text{Co}_47\text{Mo}_33\text{Cr}_18\text{Si}_2$ powder, particles of the peeled coating stuck, see Fig. 5. On the other samples, peeling no longer occurred.

Fig. 5. Stains on vulcanized rubber caused by previous peeling of the coating first vulcanized rubber in summer form coated with $\text{Co}_{47}\text{Mo}_{33}\text{Cr}_{18}\text{Si}_2$ powder
