## SCENARIO-BASED INUNDATION RISK ANALYSIS OF POTENTIAL SHIP LOCK GATE FAILURE AT KAUNAS HYDROPOWER PLANT

**Abstract.** A new ship lock through Kaunas hydropower plant is currently at the design stage. It will be the largest construction of this type in Lithuania. During exploitation, a navigation lock might be affected by numerous risk factors, such as structural deterioration, technical equipment failures, changes in environmental conditions, and human factors. In this paper the potential ship lock failure and resulting inundations when gates become misaligned due to asymmetrical pressure, jammed due to accumulated garbage or ice, or mechanical failure were investigated. The following scenario was adopted: ship lock experience failure during high probability (10%) spring flood, resulting in the total discharge of  $2,729 \text{ m}^3 \cdot \text{s}^{-1}$ . The inundations of the consequential increase of the water level in the Kaunas city were modelled using HEC-RAS software and the digital river channel relief model that combined bathymetric data with laser scanning (LiDAR) data. The results showed that most of the River Nemunas in Kaunas remains within its banks, but inundation

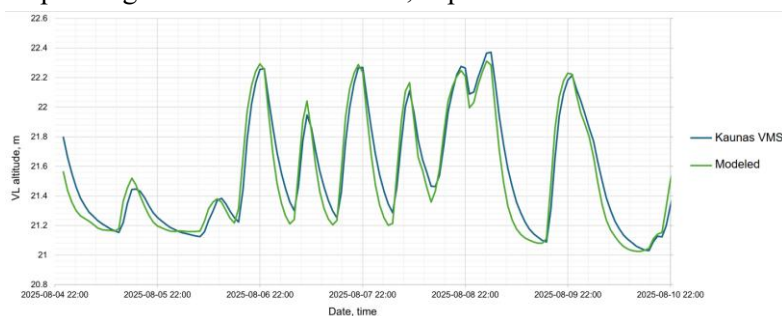
Fig. 1. Calibrated water levels for the modelled period

The calibrated water levels for the modelling period (Fig. 1) represent the time interval from 22:00 on 4 August 2025 to 22:00 on 10 August 2025. The maximum recorded water level during this period was 22.29 m, while the minimum was 21.03 m.

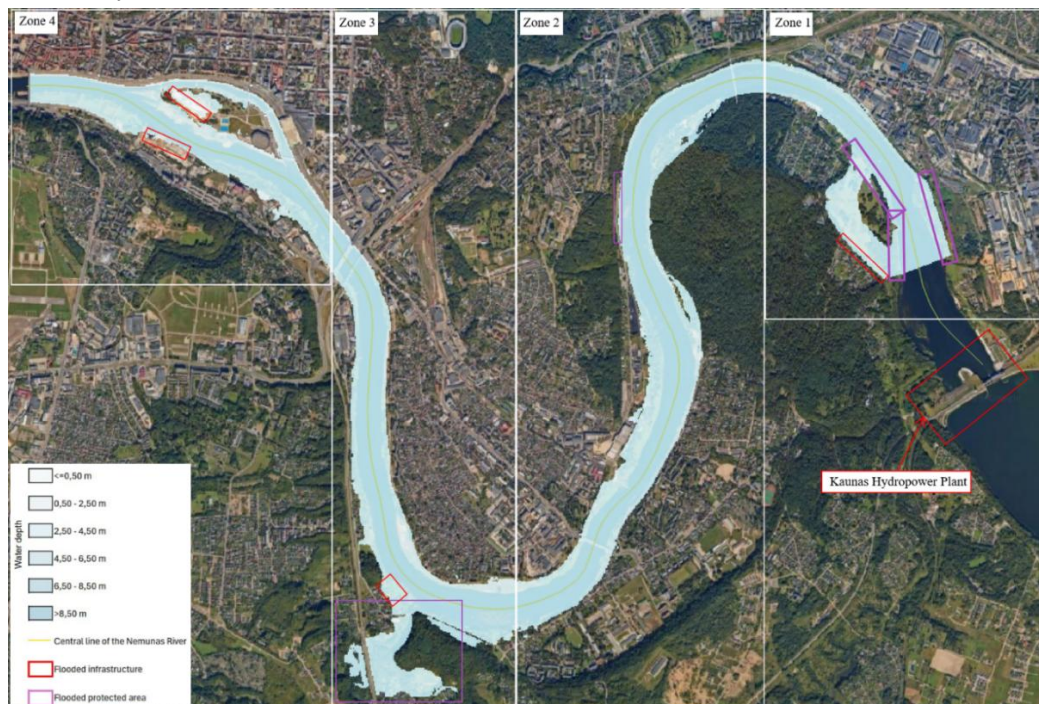
Following the analysis of a potential accident Fig. 3 illustrated that, in the event of a lock gate failure, damage would occur in all four analysed zones. In Zone 1, located in the Panemunė residential area, approximately eight residential houses would be affected, and the Kaunas ornithological reserve would be inundated. In this area, the water level would rise by approximately 5 m. In Zone 2, a lock gate failure would result in damage to approximately five commercial buildings in the Šančiai district, and part of the Aukštieji Šančiai oak grove would be inundated. Here, the water level would increase by about 3 m. In Zone 3, the failure of the lock gates would cause the River Nemunas to back up into the River Jiesia, leading to damage to the Jiesia landscape reserve, followed by damage to approximately six residential houses located nearby. In this zone, the water level would rise by around 4 m. In Zone 4, raised water level of the River Nemunas would inundate the Science Island museum located on Nemunas Island and partially inundate approximately four residential houses in the Nemunaičiai settlement, as well as commercial premises situated closer to the riverbank. In this area, the water level would increase by approximately 6 m.

Fig. 3. Results of modelling of the ship lock accident. Inundation of zones 1-4
